# Manhole Inspection Summary

Manhole # S25KK\_045MH

**Location** Address: **2218 MORRIS ST**

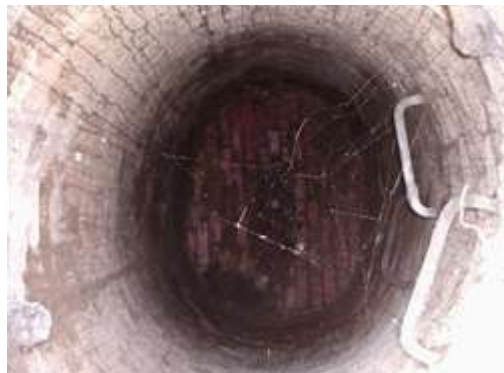
Top View

Corroded steps. Channel debris.

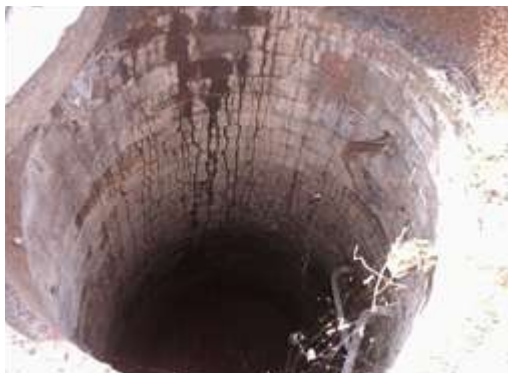
Defect

Frame leaks. Adjustment and Barrel infiltration - other side.

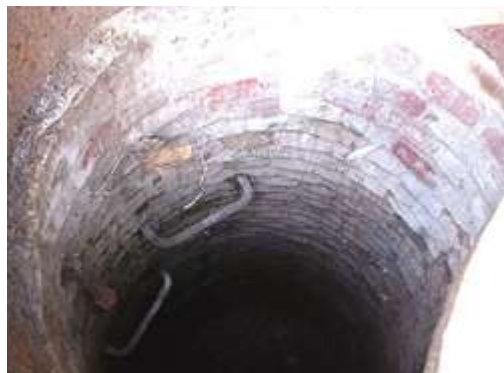
Defect

Frame leaks. Adjustment and Barrel infiltration. Missing step.
